Moody 346 starboard side chain plate inspection – John Mortimer (Wizard)

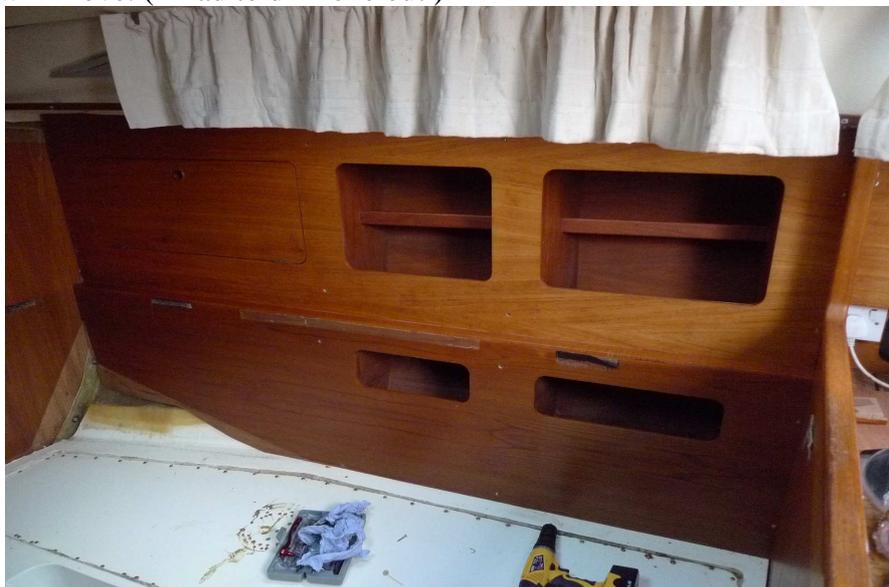
6. Remove the wooden cover plugs from both the top and bottom panels and ensure that the screws will move. (I had to drill one out)

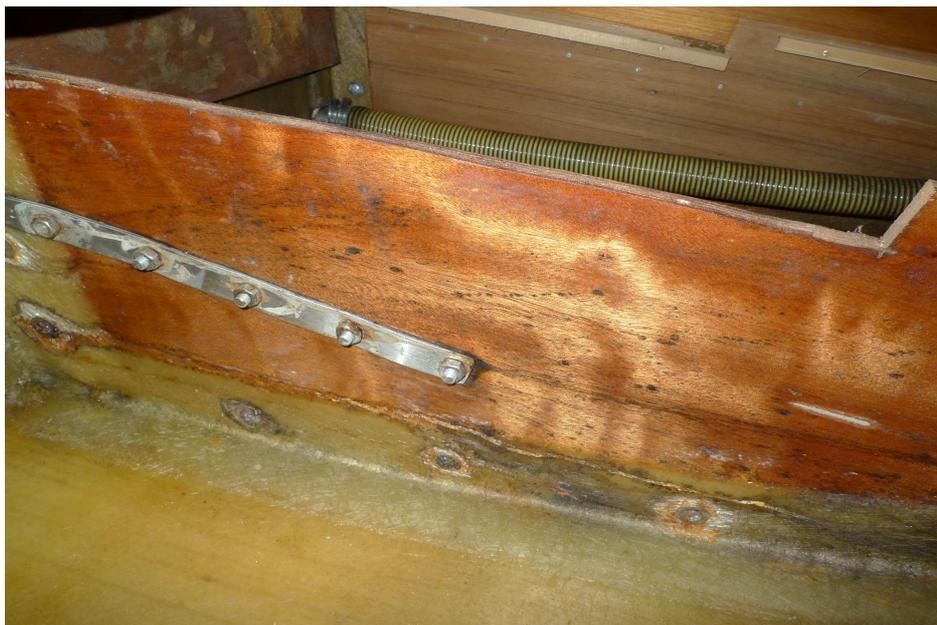
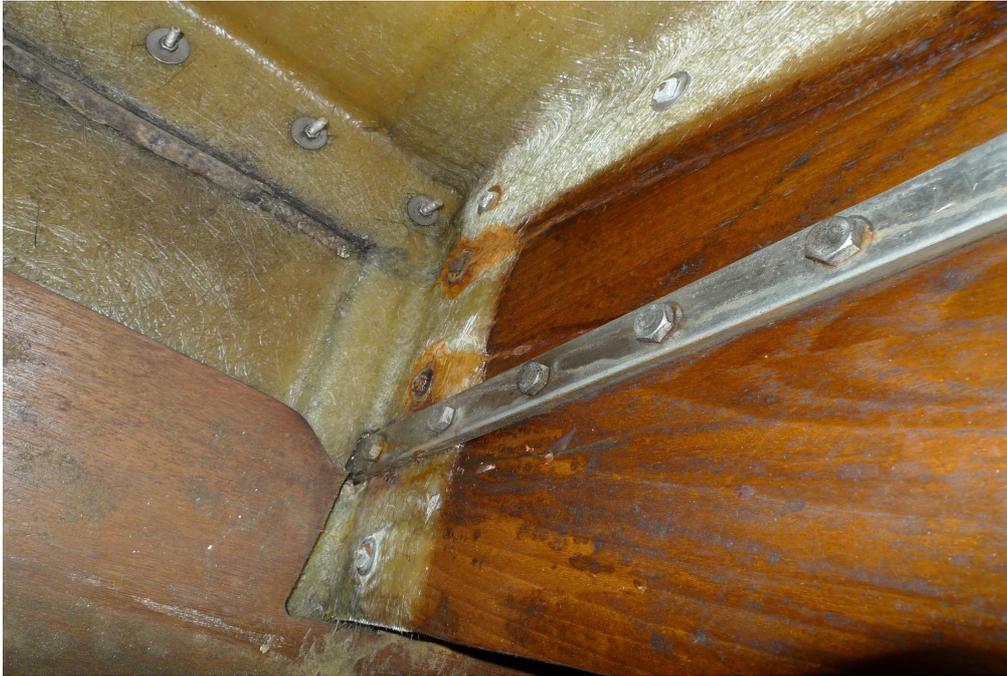
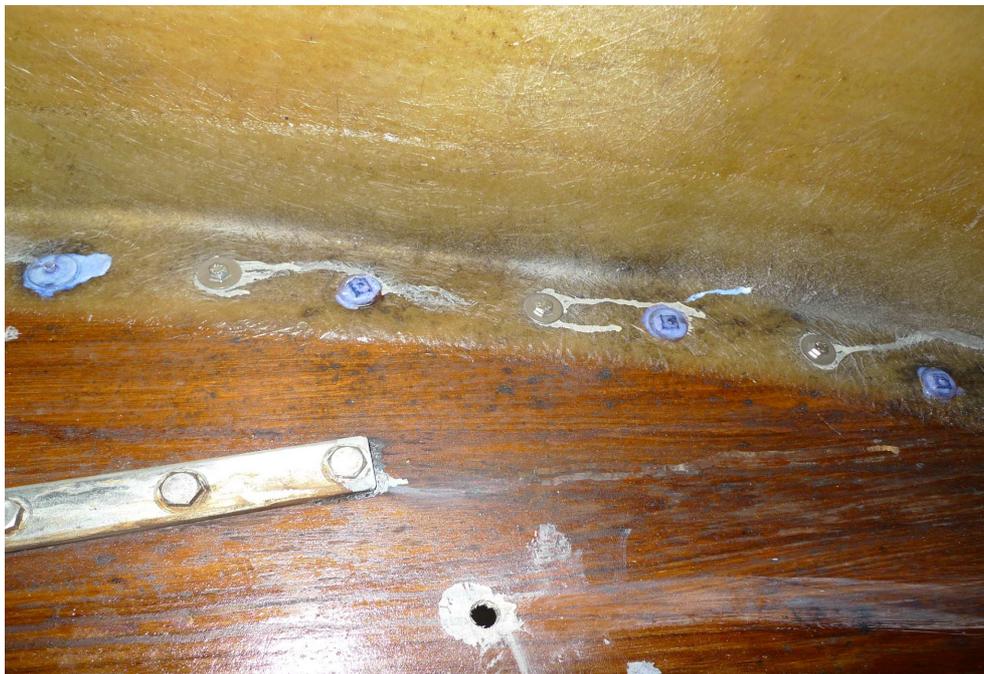
10. My 346 had clearly been leaking past the chain plates in the past. There are a row of 1/4" galvanised bolts around the hull – mine had evidence of corrosion and proved impossible to remove easily. I therefore drilled and inserted stainless M6 bolts, penny washers and nylock nuts between the existing bolts. Don't do them up too tight as you may distort or crush the GRP and break the seal. All the holes were painted before the new bolts were inserted and the existing bolts were treated with a rust preventer – its the blue looking paint in the pictures (I used Vactan – just my preference but there are lots out there)
