Moody 346 starboard side chain plate inspection – John Mortimer (Wizard)

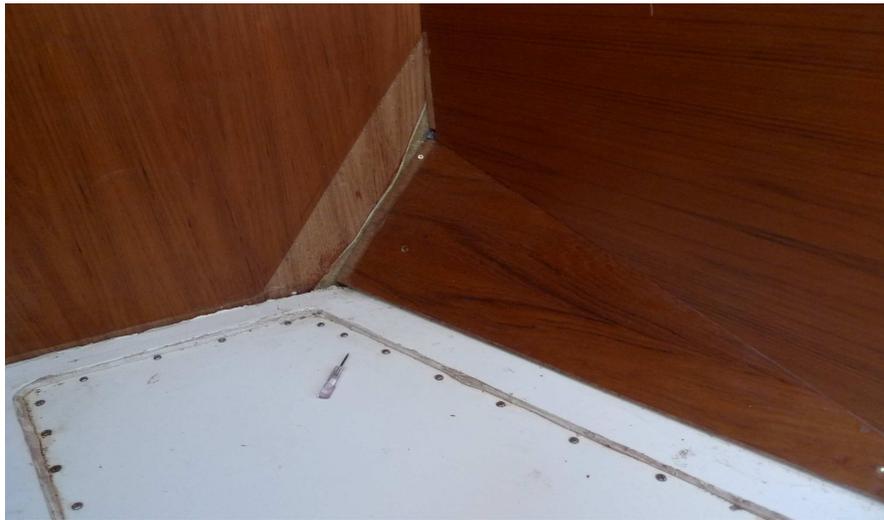
1. Remove trim panel on the forward bulkhead by sliding sharp blade between it and the bulkhead and carefully lever it off– held by 3 small tacks

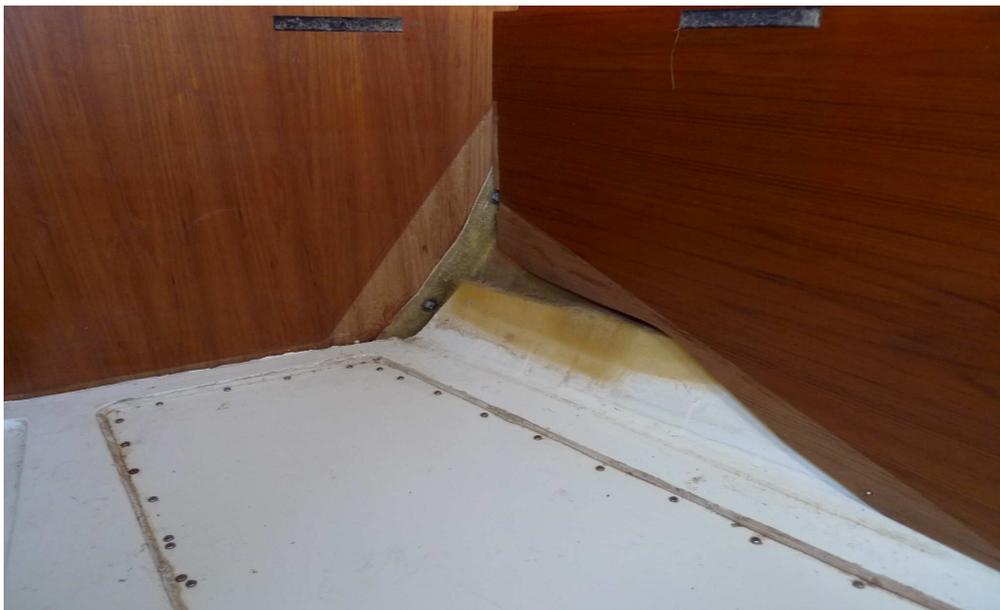
2. Remove the plywood cover over the water tank – held on by 8 small screws
3. Remove the triangle plywood plate – 3 screws

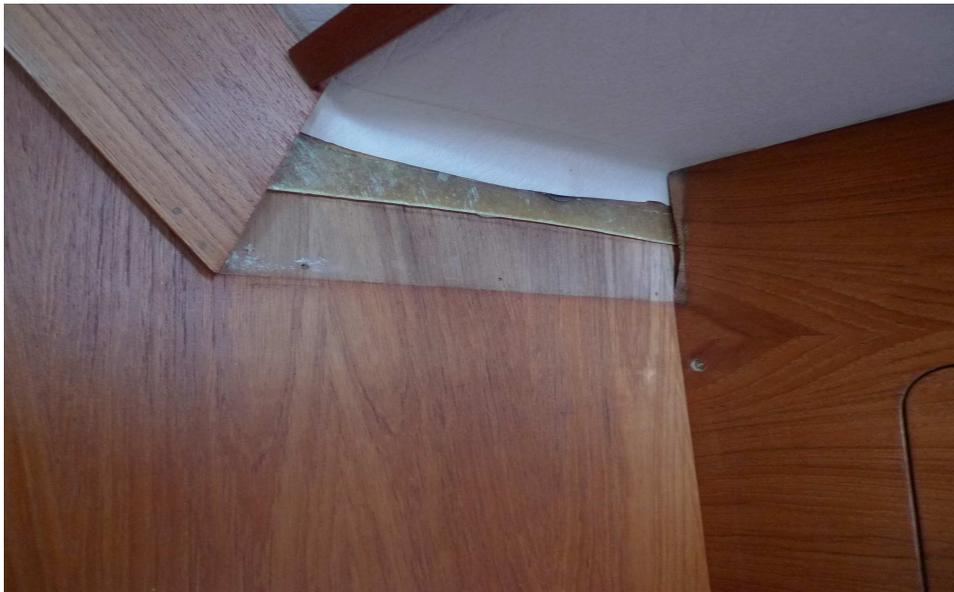
4. Remove trim panel on the top forward bulkhead near the window by sliding sharp blade between it and the bulkhead and carefully lever it off– held by 3 small tacks

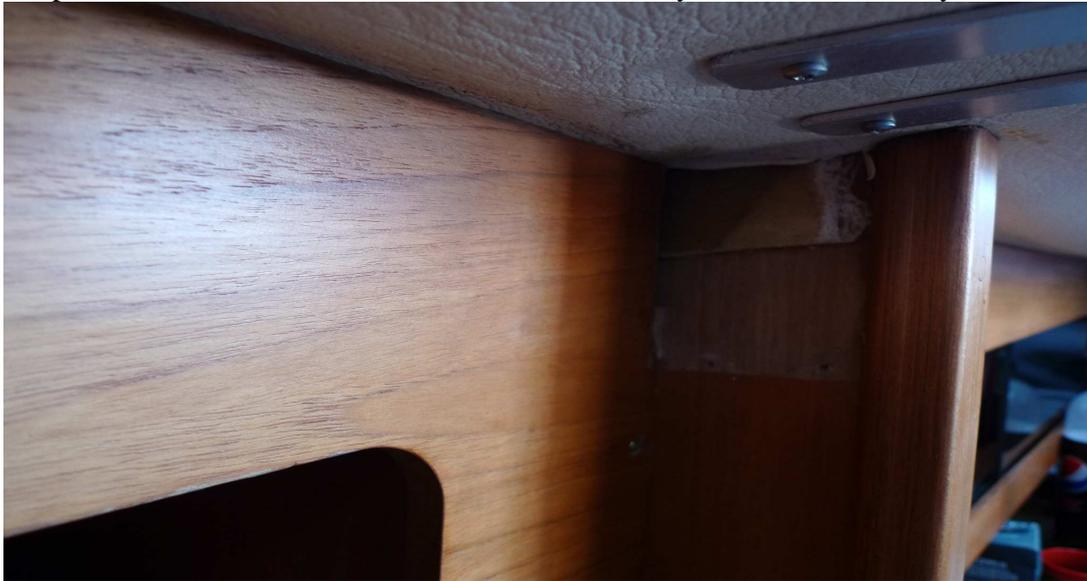
5. Remove trim panel on the top of the bulkhead next to the galley near the window by sliding sharp blade between it and the bulkhead and carefully lever it off– held by 3 small tacks

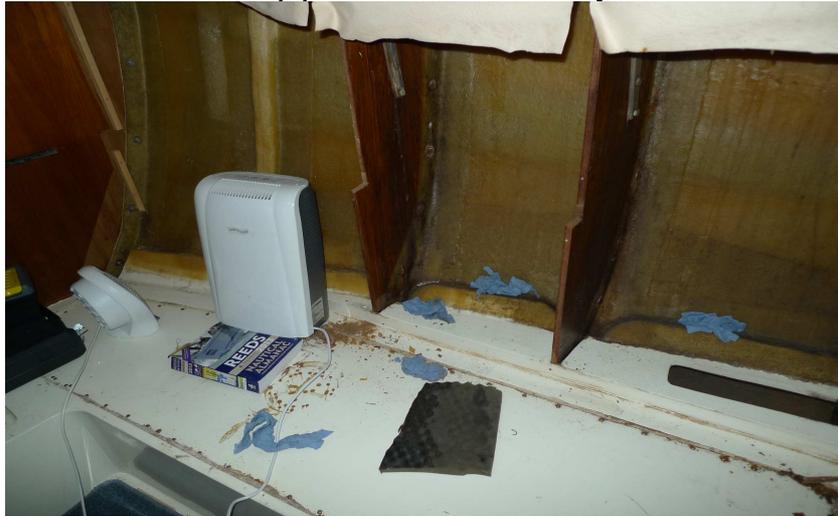
7. Remove the screws from the bottom panel and then carefully slide it out – forward end first – supporting the weight of the top panel.
8. Remove the screws from the top panel and then carefully slide it out.
